UPCS in Pictures

The following pictures are not all inclusive nor does it cover every deficiency. The pictures, however are some of the most commonly cited deficiencies on REAC inspections.

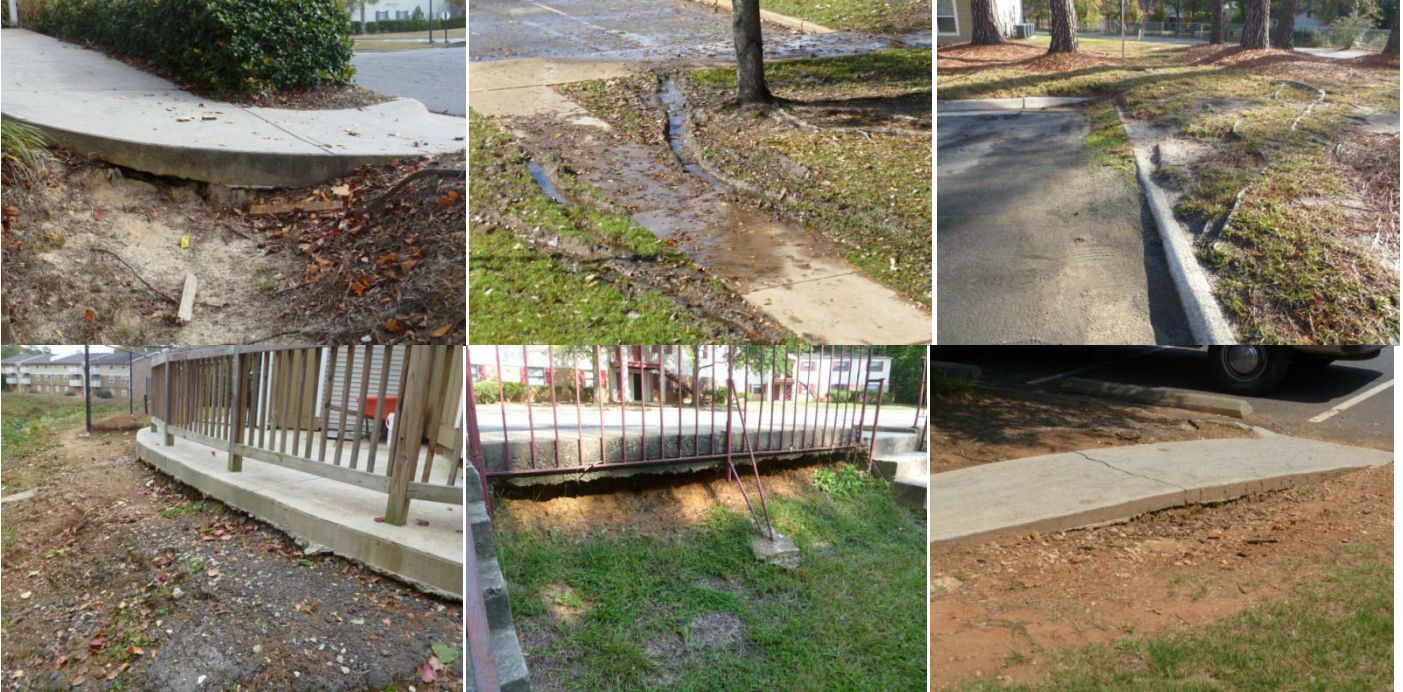
Erosion

The pictures below show various types of erosion and rutting. Even the man made tire track is a deficiency.

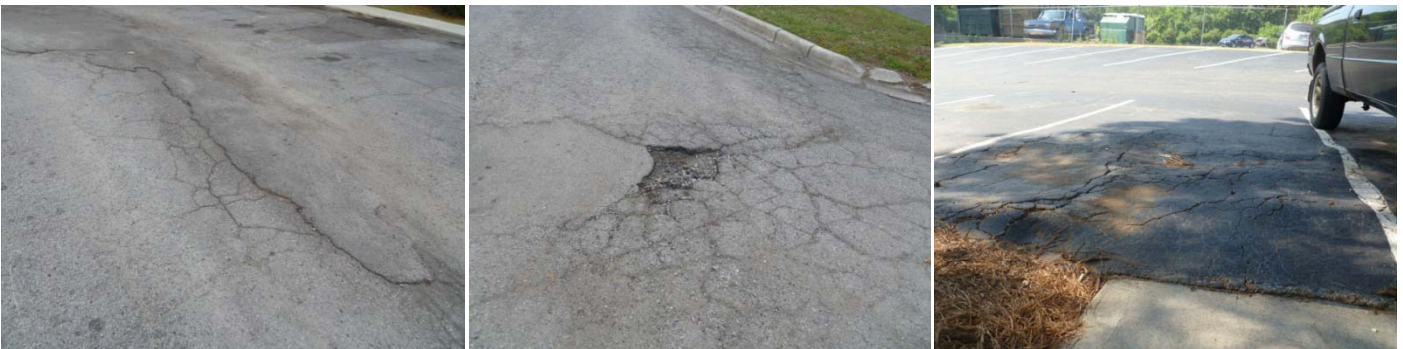
Pavement damage includes cracks, potholes and settling/heaving asphalt. Potholes, if more than 3/4" deep can also be considered a HS-Trip Hazard

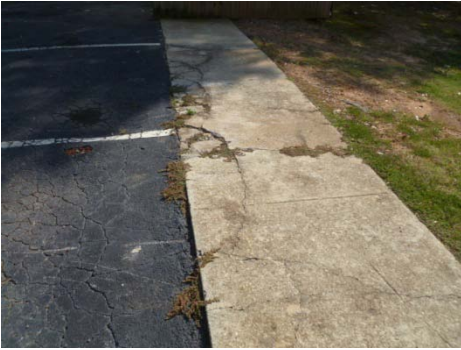
Sidewalks can have various deficiencies but the most common is cracks as shown below.

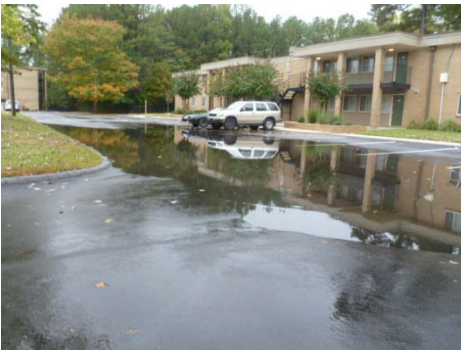
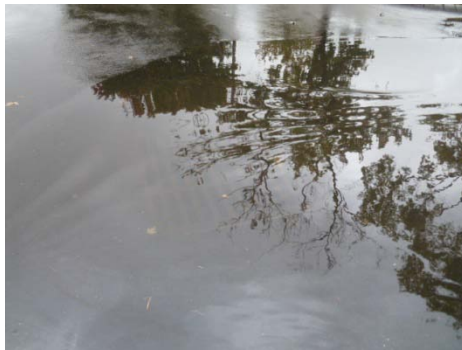
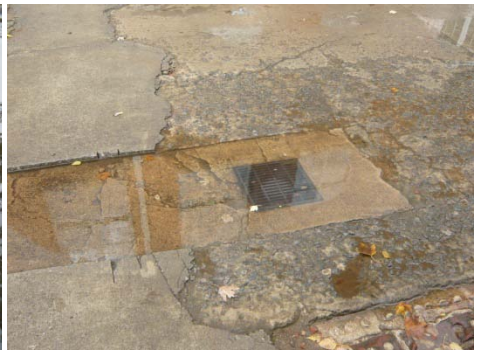
Drainage

Site ponding is relatively uncommon as shown in one of the pictures below, however in this case it is caused by a clogged drain. Clogged drains are most common in smaller drains by basement entry areas. Debris in and around site drains is not a deficiency according to the UPCS unless water is present.

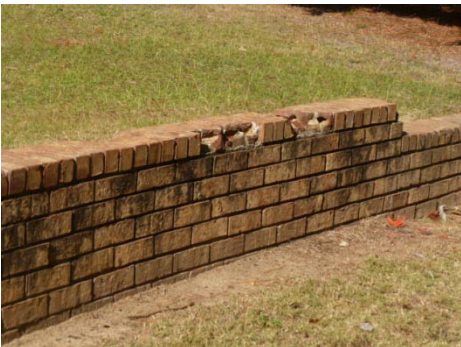
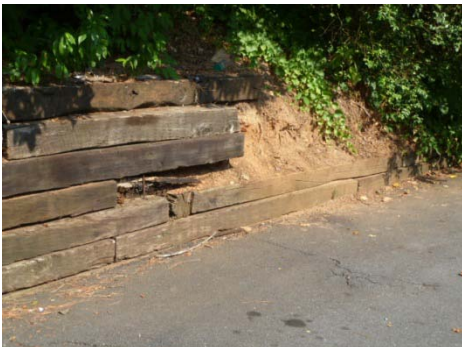
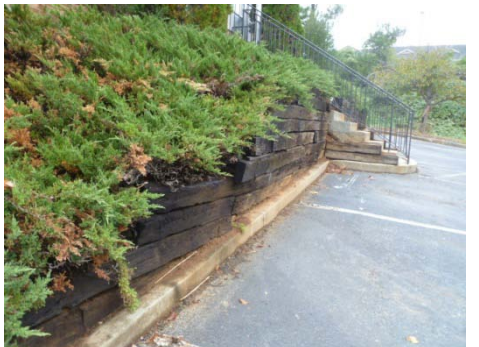
Retaining Walls

Retaining walls are vaguely defined by the UPCS so it could technically be a landscape timber around a flower bed keeping mulch contained. Below are more obvious retaining wall deficiencies. The first picture is a Level 2 while the other two are clearly Level 3.

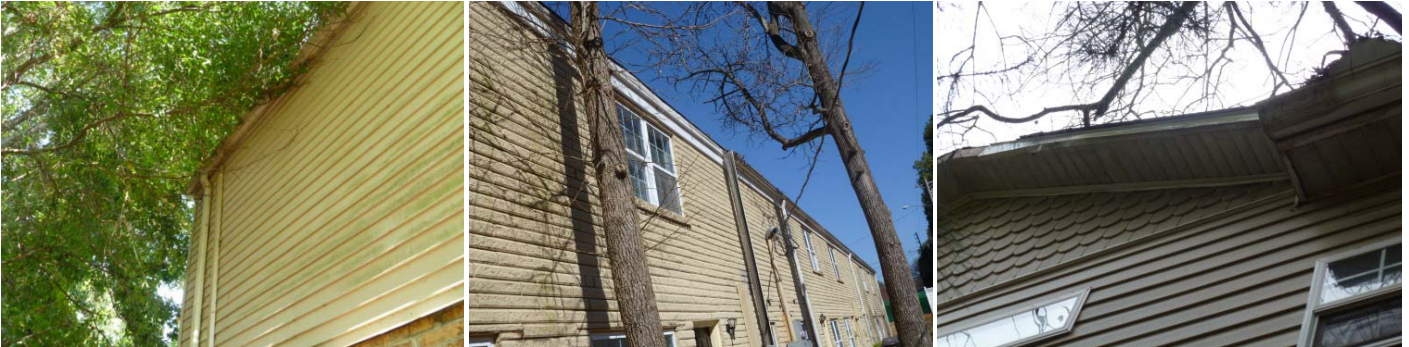
Overgrown Vegetation

Vegetation touching an unintended surface including tall grass is a deficiency. Vines or weeds growing on fences are often cited. Here are pictures of trees and branches touching buildings and in two of the cases damaging gutters, soffit and shingles.

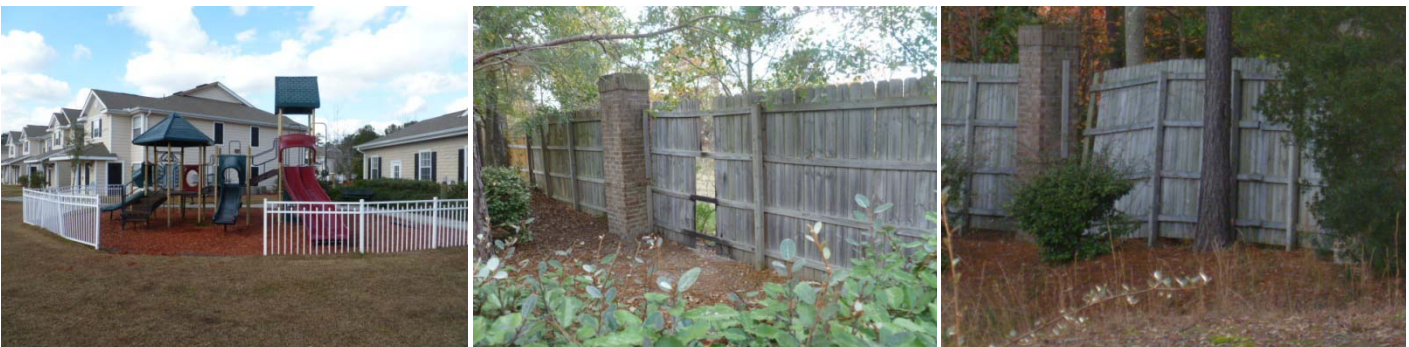
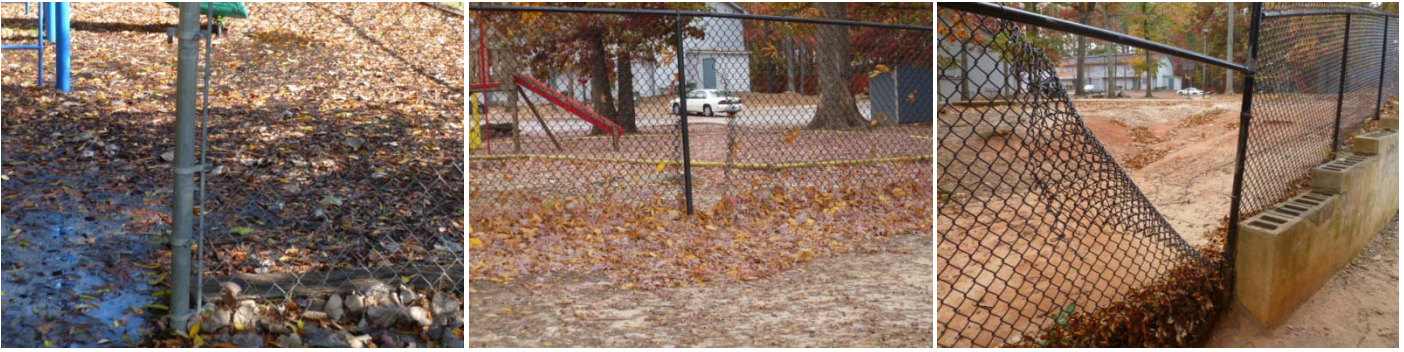
Fences are divided up into interior, exterior and security. Deficiencies vary from minor fence deterioration to missing sections and holes. Missing and damaged gates are common deficiencies. If a property removes a gate, they must also remove the hinge hardware or the gate is considered missing

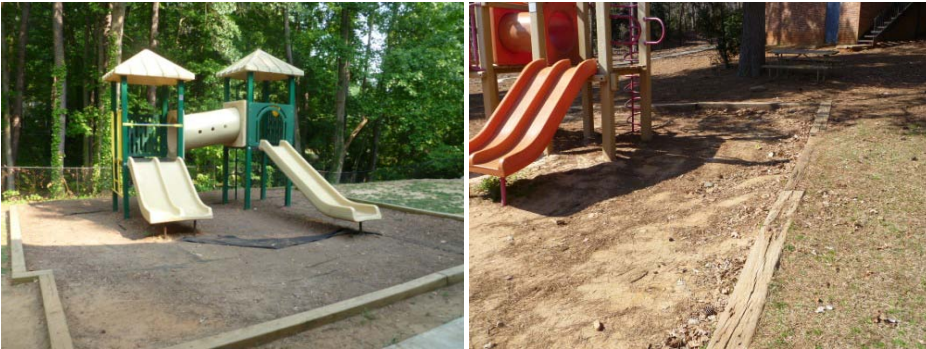
Playgrounds

Surfacing material deterioration deficiencies are based on a total percentage.

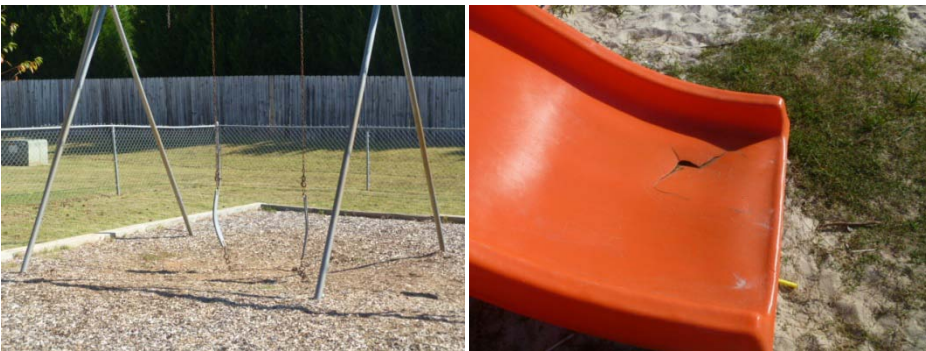
Playground deficiencies are based on the percentage of either missing or damaged equipment, however if as in the below examples, the equipment poses a safety hazard, it is an automatic Level 3

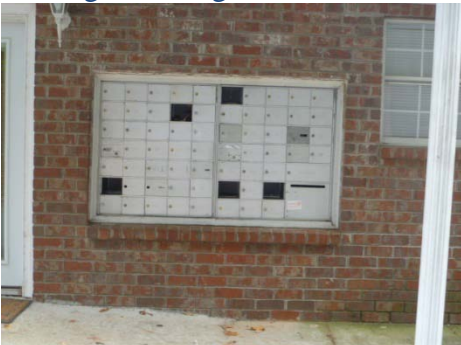
Mailboxes

Missing or damaged mailboxes are a deficiency. Below the doors are off several on the resident mailboxes.

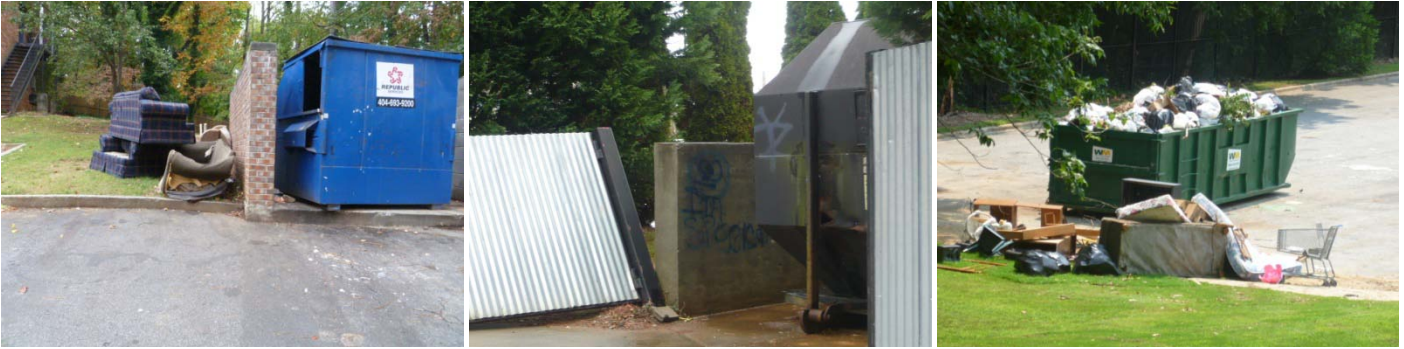
Trash Enclosures

The most common deficiency in this section is that the designated area is not large enough to store the garbage until collection. The other is that the enclosure has collapsed or leaning and in danger of falling.

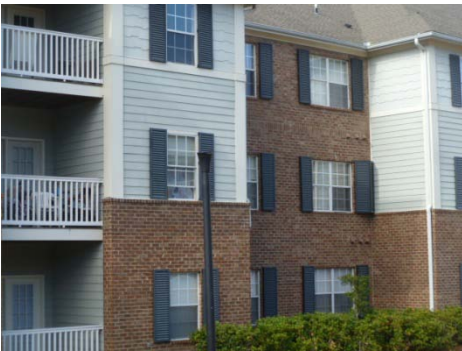
Lighting

Site lighting is damaged in the picture below. The UPCS will associate this deficiency with the building closest to the light fixture as there is no UPCS lighting deficiency.

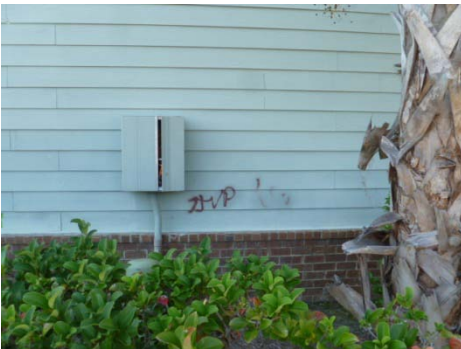
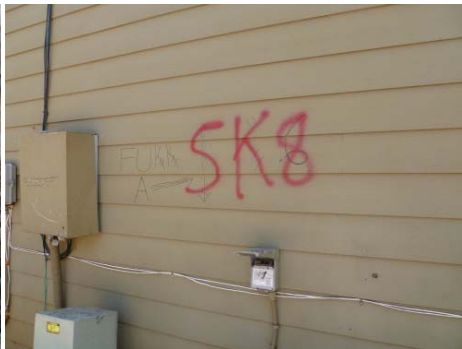
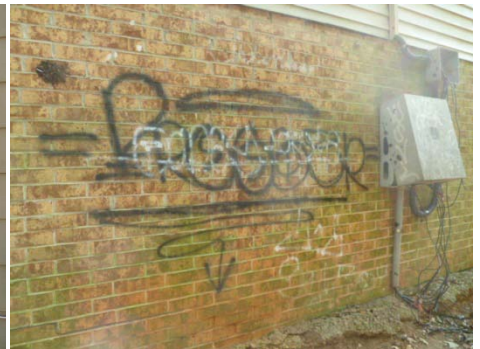
Graffiti is in all sizes and shapes. The deficiency is determined by how many places on a site graffiti exists.

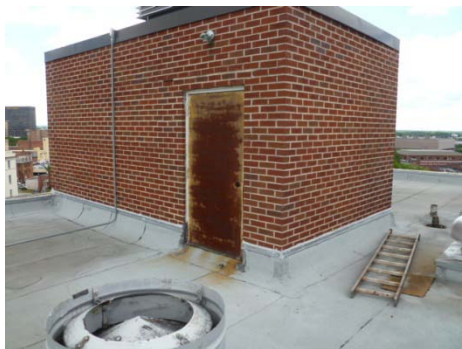
Doors can have many deficiencies. The below pictures show some common surface damage issues, the biggest being removed hardware leaving behind a hole.

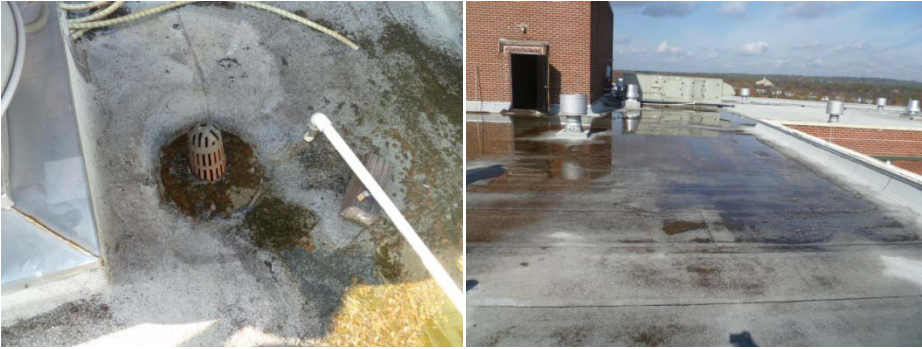
Flat Roofing

Flat roofs have some common issues. Roof drains are either clogged or has debris around them and large flat roofs have ponding.

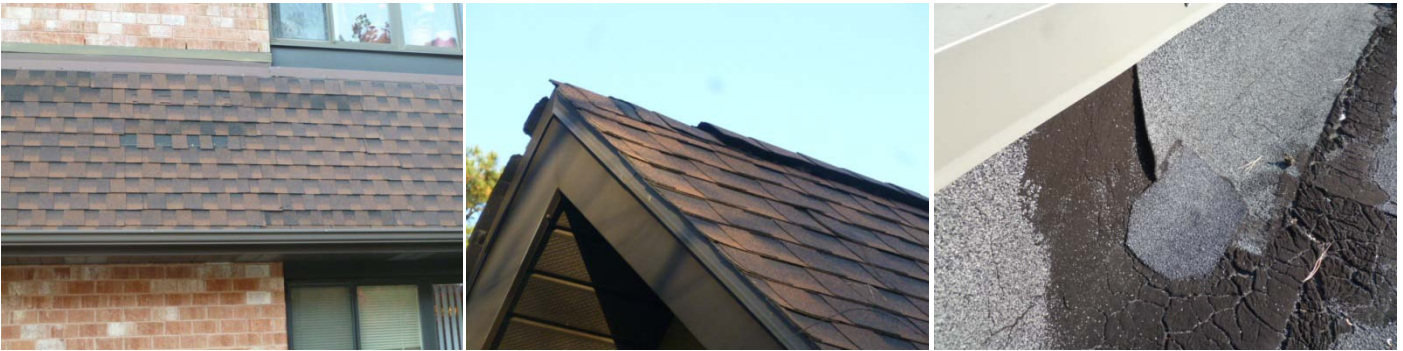
Roofing Material

Missing or damaged shingles are common while flat roofs often have small gaps in the material causing potential water penetration.

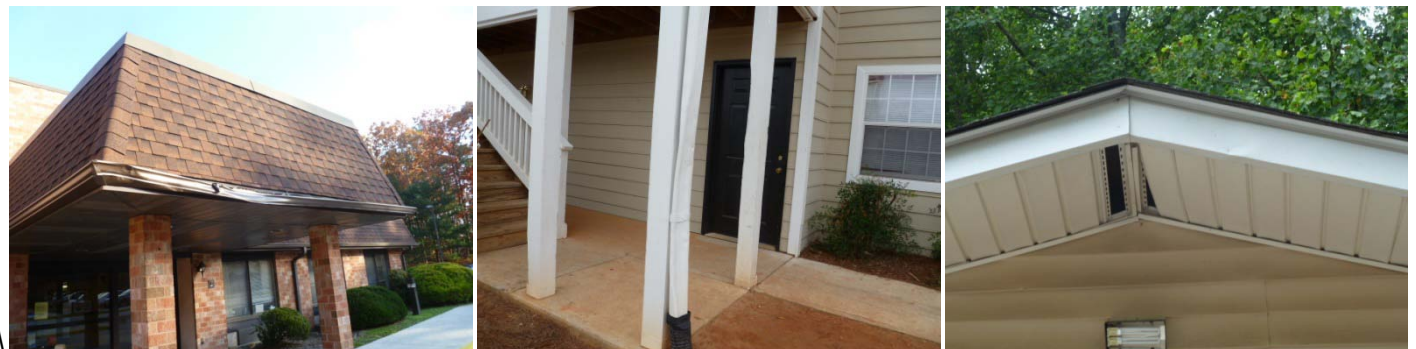
Gutters

Damaged or missing gutter components are pretty common but not as much as the missing splash blocks. The other picture shows some missing soffit material which is just a Level 1.

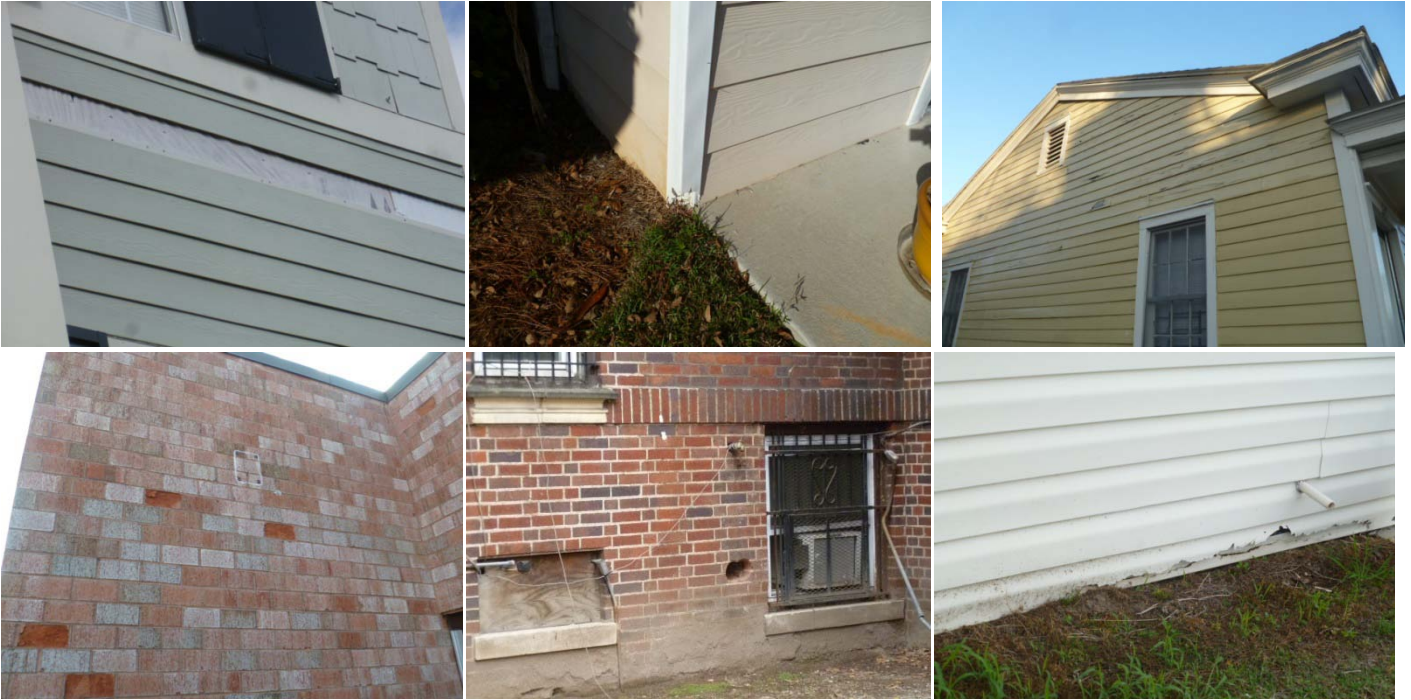
Walls-Siding

Siding can have peeling paint, missing pieces or damage from the weed whacker. Bricks have spalling or pieces missing such as small chips or holes especially from abandoned pipes or hose bibs.

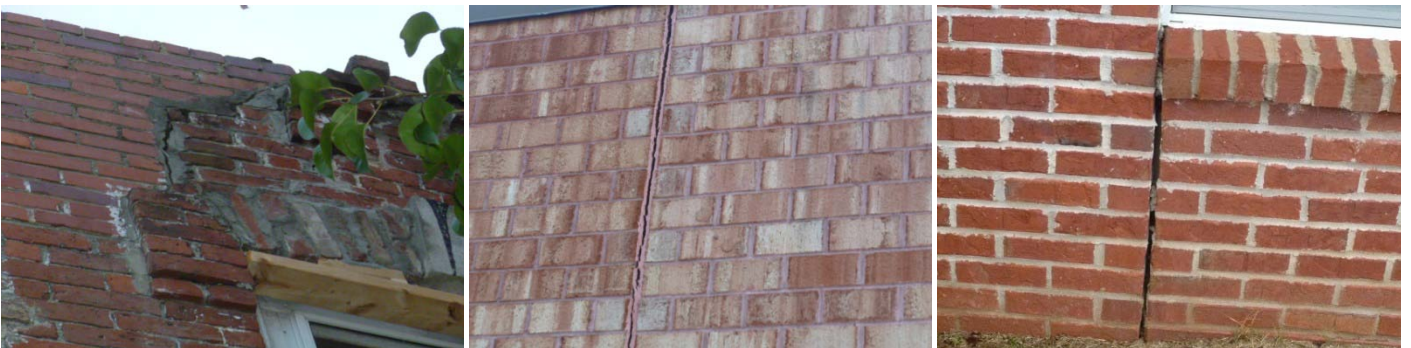
Walls – Cracks/Gaps

Missing mortar or sealant in wall expansion joints and cracks/gaps are often seen on brick buildings.

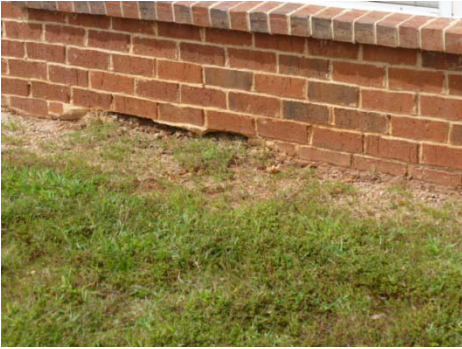
Foundations often have cracks or gaps. The picture shows a large gap. The one item not to avoid here is the cracked basement floors as that deficiency is recorded under foundations.

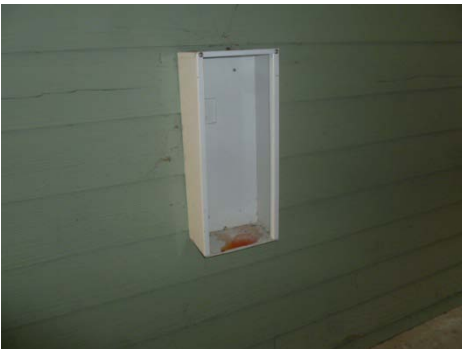
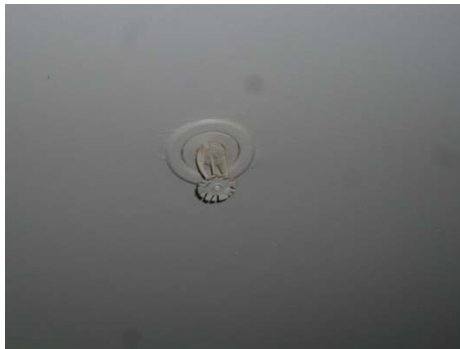
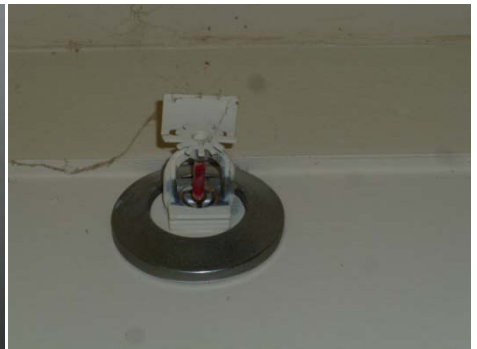
Fire Protection

The deficiency that is easy to understand is the missing or discharged fire extinguishers. More common is fire extinguisher with expired inspection tags. Then there is the painted sprinkler heads...painted over is one thing because they probably will not function as they should, but paint anywhere on the sprinkler head is a Level 3 deficiency that can cost a single building property nearly 17 points if found in just one location.

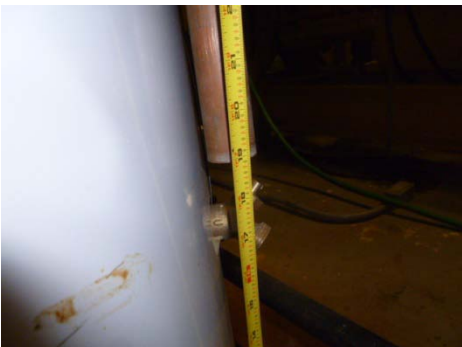
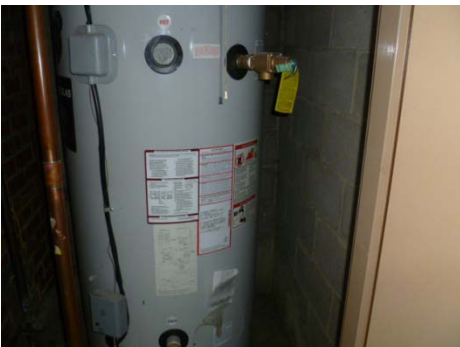
Domestic Water/Hot Water Heaters

Pressure relief valve pipes are required on hot water heaters and the UPCS protocol states that the pipe must not be more than 18" from the floor.

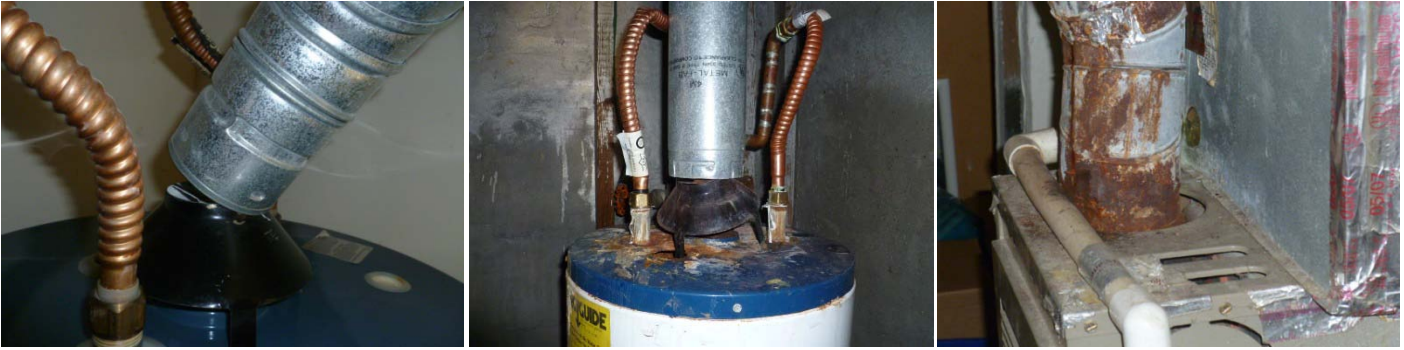
Hot water heater exhaust pipes that are improperly vented are shown below as well as significant rust on the piping associated with the HVAC system.

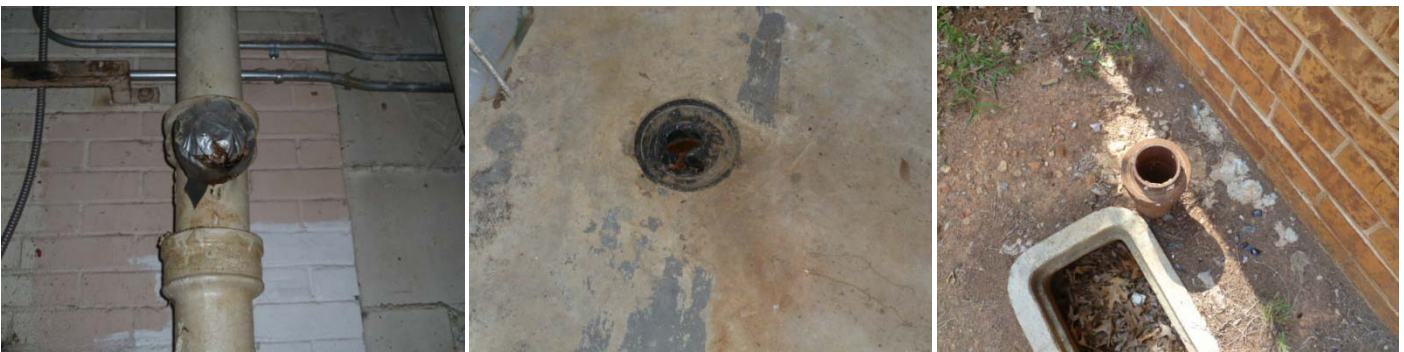
Sanitary System

The below pictures show a leaking waste line, missing floor drain cover and a missing cleanout cover. These are all Level 3.

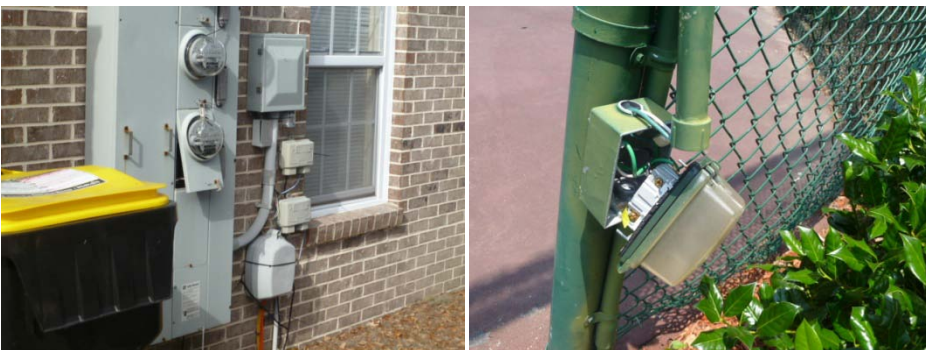
Electric Hazards

The pictures show some unusual situations. The first is an unsecured meter pan cover which is a health and safety *other* as UPCS considers it to be utility owned. The other is an outlet hanging out of the box showing exposed connections...this one will really hurt your REAC score.

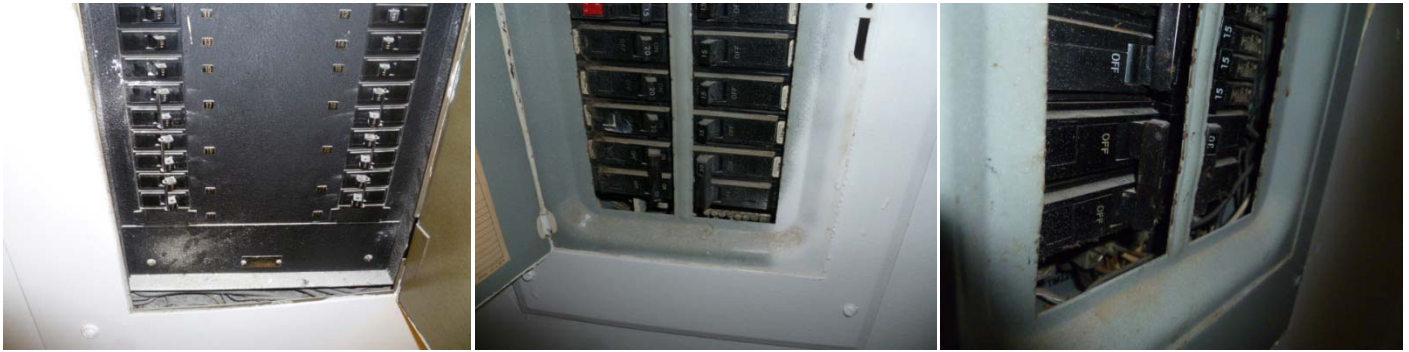
The below electrical hazards are all too common. The space between the breakers and the cover, or the space between the panel's interior cover and external ones causes a health and safety deficiency when the gap is more than ¼".

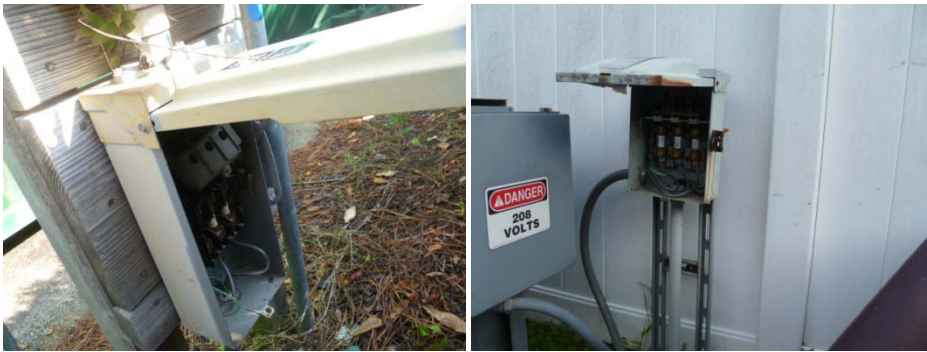
The below pictures are of unsecured disconnects. These are so common. Secure all disconnects as well as any other electrical device box. Zip ties suffice.

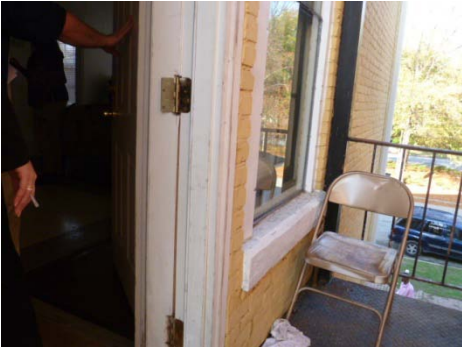
Doors

The picture below shows a missing entry door to a common hall. Keep in mind that any time you remove a door intentionally, all signs that it was ever there must also be removed or it is considered a missing door deficiency according to the UPCS.

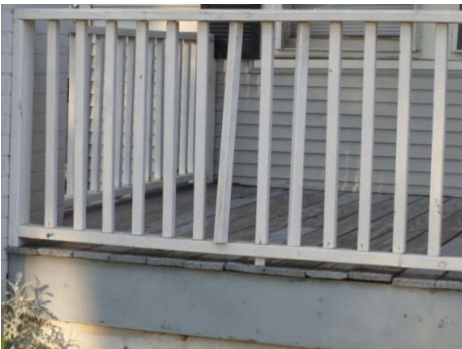
Porches

The main issue with porches and railing is damaged or missing balusters. In fact, the only deficiency on a unit porch is the railing.

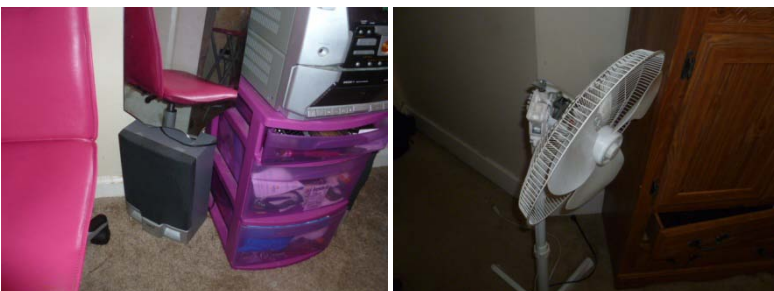
Hazards – Other

It is always a surprise to a property representative when resident items are cited. The below pictures show a broken mirror placed on top of a speaker, the other is a missing cover off a floor fan. The hazards-other contains unit trip hazards, sharp edges and other. The sharp edges penalizes the property's REAC score while the others are non-scoring items

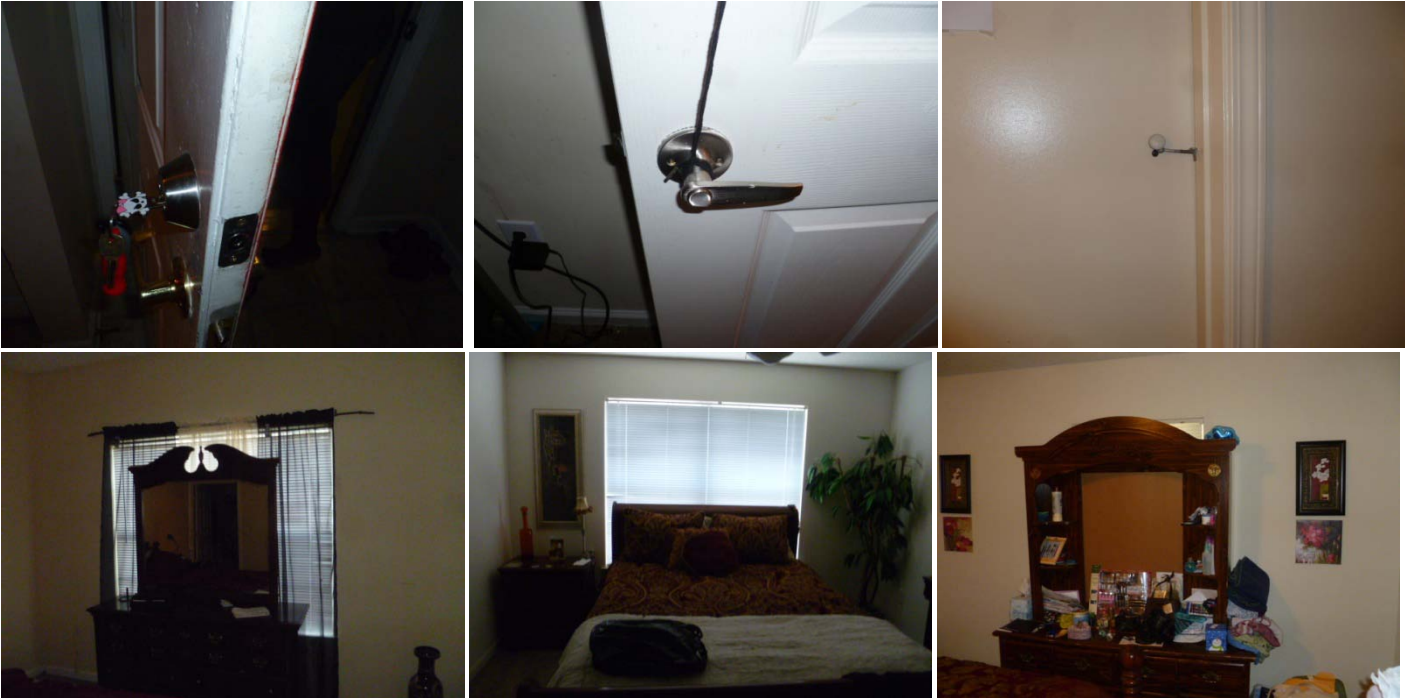
Emergency Exits

There are many variations of a blocked egress in a unit but the below pictures are the most common. They are as follows: double keyed lock on a unit entry or bedroom door; bedroom or bathroom door lock is reversed; latch or padlock on the outside of bedroom doors; furniture blocking only windows in a bedroom.

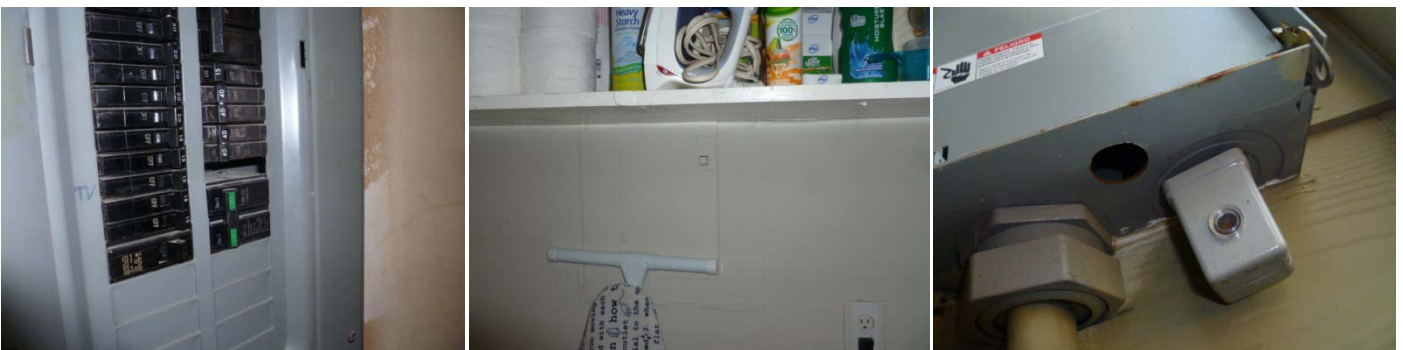
Electrical

These situations can happen in units or elsewhere. The first is a missing breaker in a panel box, these must have a proper black installed, the second is blocked access to the panel box, in this case they had a shelf installed right in front of the box and the third is a missing knockout in a panel or other electrical box.

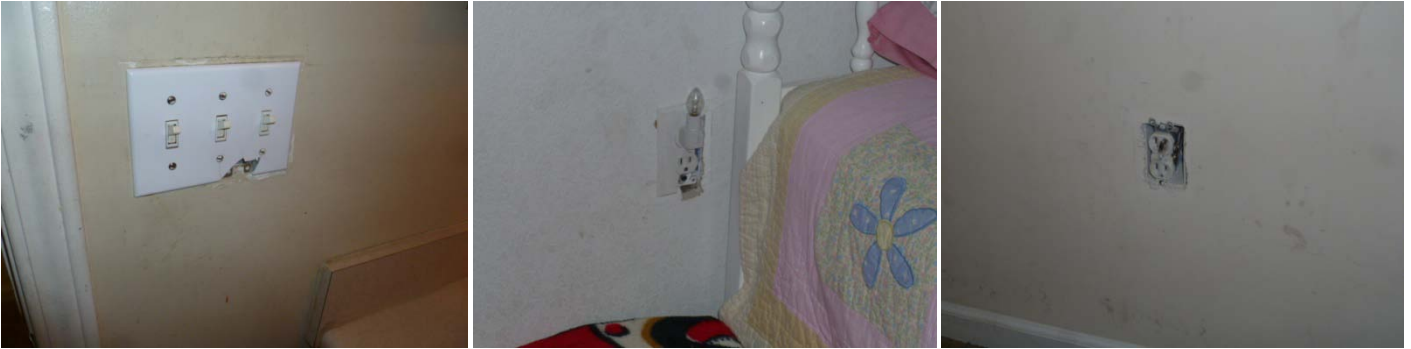
Outlets

Broken or missing outlet or switch covers is always an issue, especially in the units. Missing and broken plates exposing electrical connections is a Level 3.

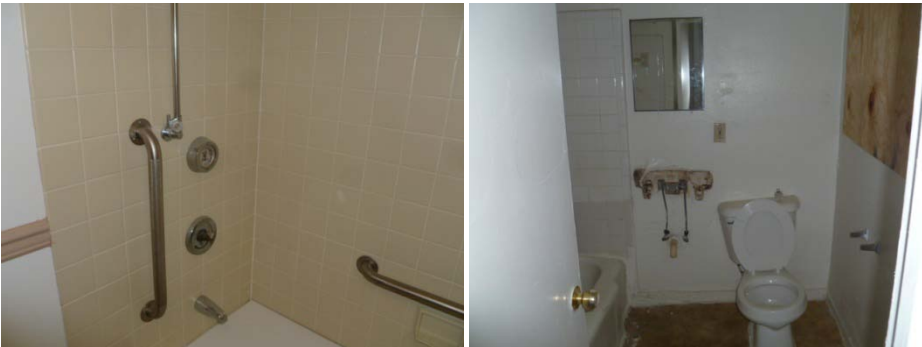
Bathroom

Missing sink or tub stoppers are pretty common. The pictures below show a shower diverter that has missing pieces and does not function, the other has a missing sink.

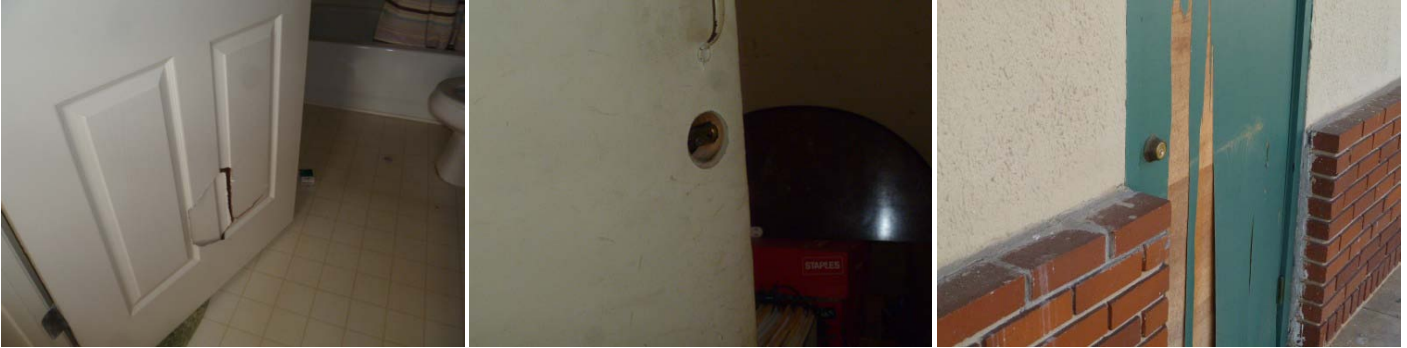
Doors

Door surface damage is pretty obvious in the first and third picture. The middle picture shows a door with missing hardware which is always recorded as surface damage.

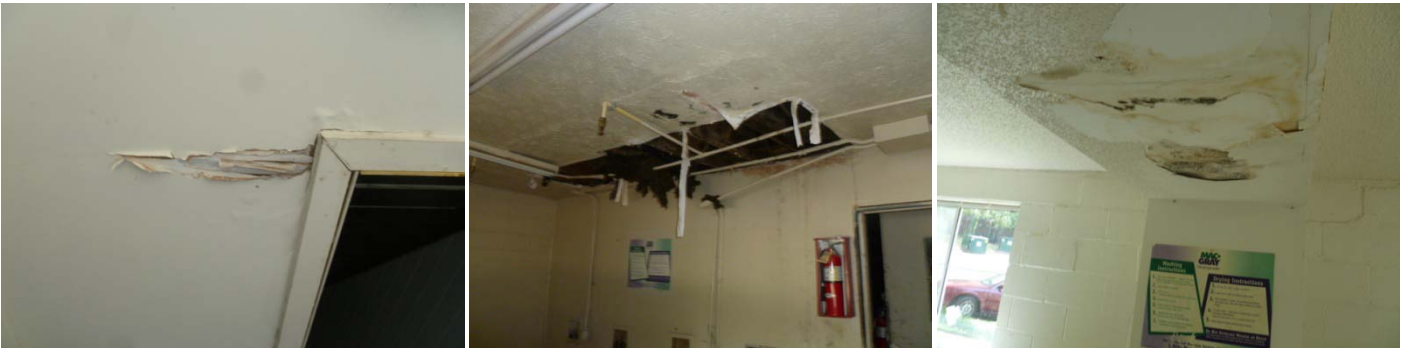
Ceilings

The below ceiling have peeling paint and water damage.

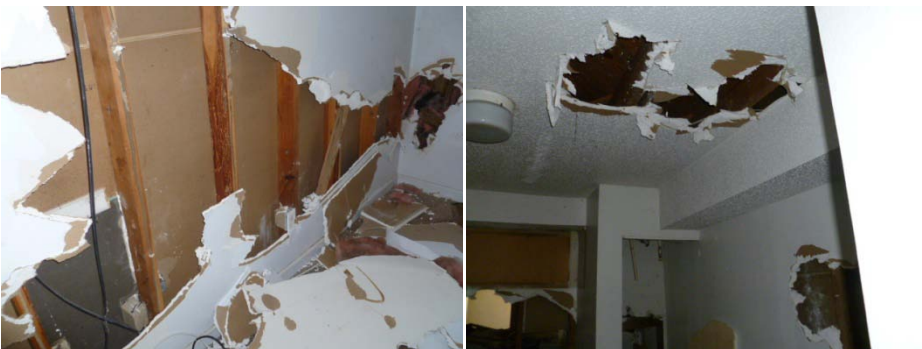
Ceiling and Walls

Ceiling and wall damage is normally seen to this extent but any damage affecting an area larger than 1" is a deficiency.

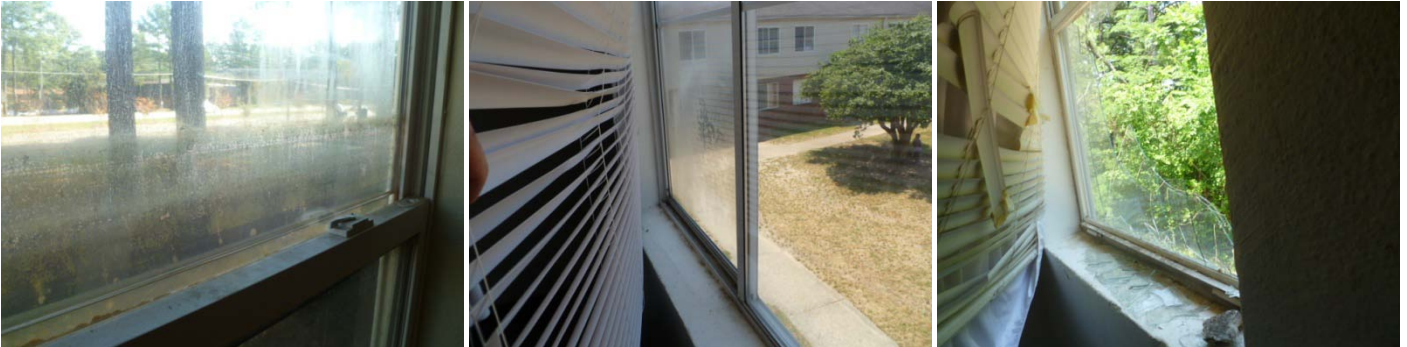
Windows

Window usually only have a few deficiencies. They are a cracked or broken pane shown below and condensation between the panes caused by damaged seals. Broken window panes are often also a health and safety deficiency for sharp edges.

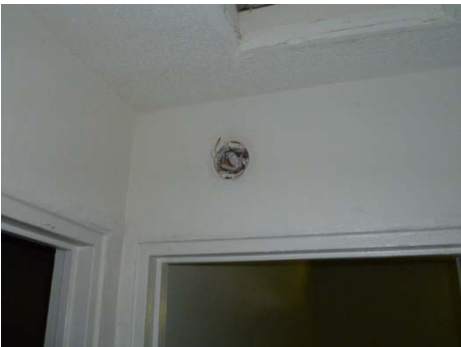
Smoke Detectors

Smoke detectors are one of the few things required by UPCS. They must be installed on each level of a unit including the basement. Missing and inoperable smoke detectors are considered exigent health and safety deficiencies. This deficiency is non-scoring on a REAC inspection.

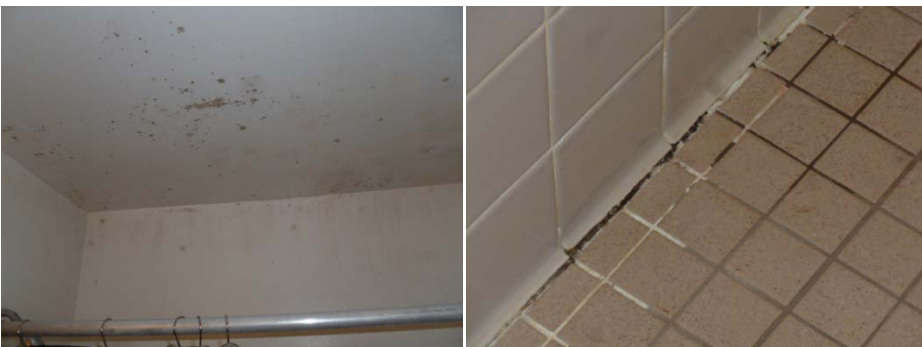
Air Quality

Here are a few examples of mold commonly found in bathrooms.

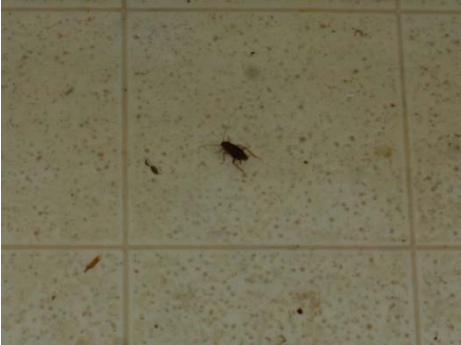
Infestation

Roaches dead or alive are considered infestation as well as any signs that they exist. Mouse/rat dropping is too.

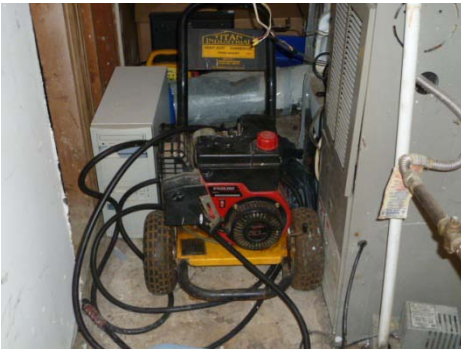
Flammable Material

Flammable materials cannot be stored in units or residential buildings unless it is in the garage. The picture shows a pressure washer with gasoline in the tank stored next to the boiler in a unit.

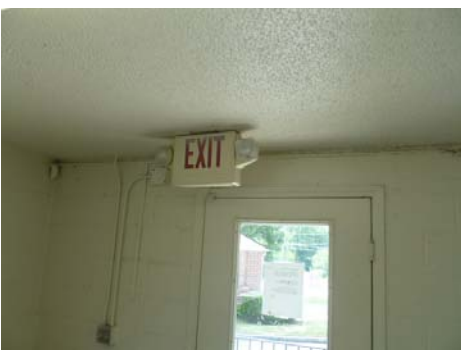
Emergency Exits

Exit signs are not required by UPCS however if they are there they must be illuminated day and night. The picture shows an exit sign that is designed to be internally illuminated and it's not. If these exit signs have a test button, they must function as they should which is that they remain illuminated by battery power.
